Marine Rescue Victoria Point

FLIREX

Introduction

On the evening of Tuesday 10 July 2018, an experiment was conducted to test the impact on Forward Looking Infra-Red (FLIR) cameras as a result of a person's temperature dropping while in the water.

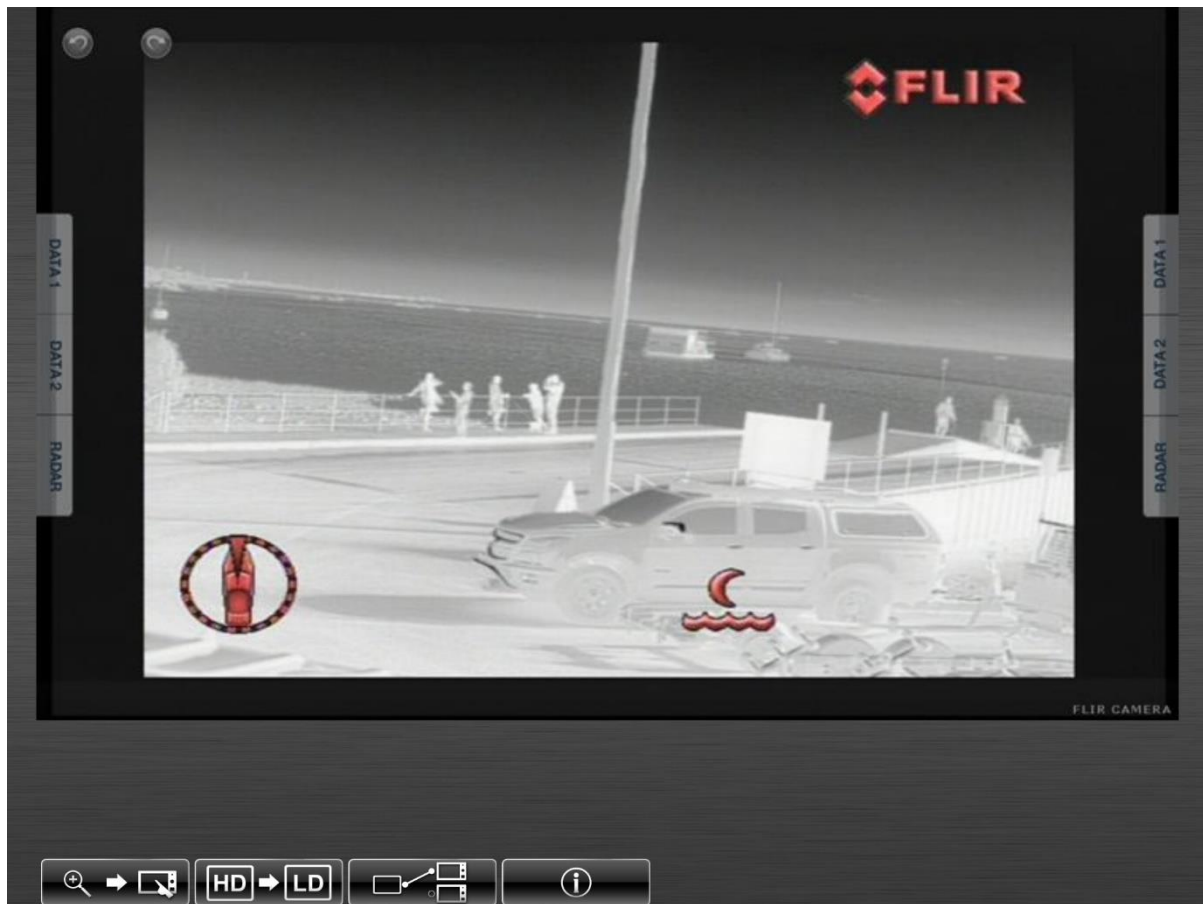
Taking photographs of the FLIR displays in the dark was not considered very successful. The TZ14 has an app which allows a mobile device such as an iPad to act as a slave display. Taking screenshots on an iPad using this app delivers considerably improved images as below. This technique is recommended for any similar activities where possible.

The FLIR images themselves were clear and effective.

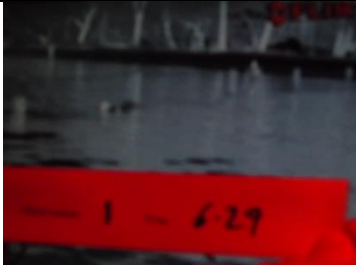
ID	Minutes	Lifejacket	Victoria Point 1		Water Police Baggly	
			Image	Comments	Image	Comments
1	0	None

Head clearly visible	No image	Aerial interference
2	+3	Level 50

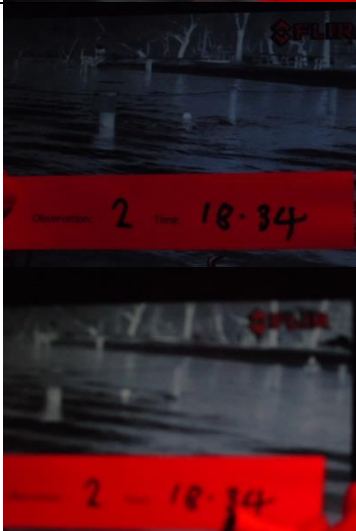
Head clearly visible – slightly higher in the water

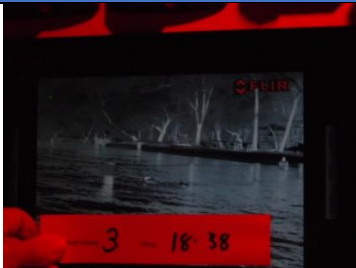
ID	Minutes	Lifejacket	Victoria Point 1		Water Police Baggly	
			Image	Comments	Image	Comments
3	+5	Full Coastal

Head clearly visible – Sitting higher still in the water

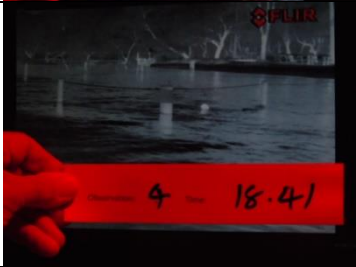
4	+7	None

Head clearly visible – Lower in the water

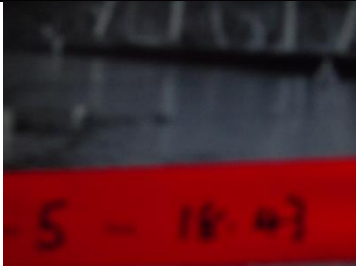
5	+12	Level 50

Head clearly visible – Again higher in the water

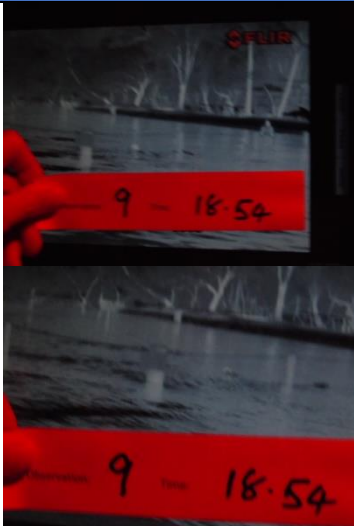
ID	Minutes	Lifejacket	Victoria Point 1		Water Police Baggly	
			Image	Comments	Image	Comments
9	+25	Full Coastal

Head clearly visible – Again highest position in the water but less than before

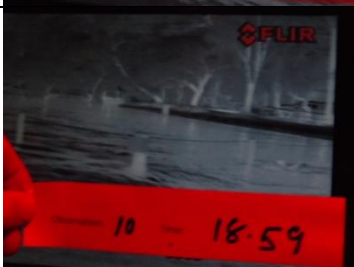
10	+30	None

Head visible Attempted to take body temp at this stage. Could not get a reading. Water temp 15.2deg

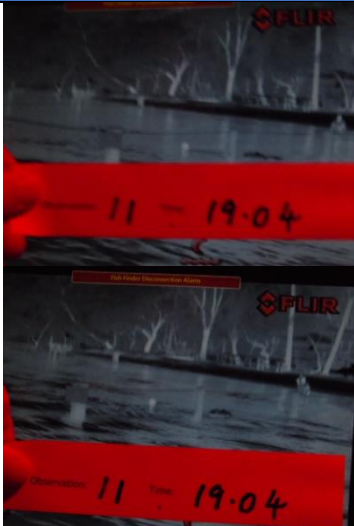
ID	Minutes	Lifejacket	Victoria Point 1		Water Police Baggly	
			Image	Comments	Image	Comments
11	+35	Level 50

Head visible – lower in the water

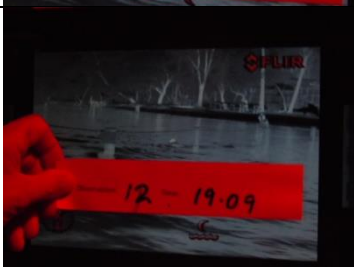
12	+40	Full Coastal

Head visible – Dave commented he felt warmer in the full coastal

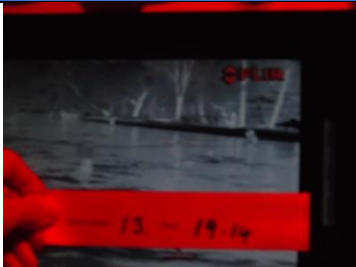
ID	Minutes	Lifejacket	Victoria Point 1		Water Police Baggly	
			Image	Comments	Image	Comments
13	+45	None

Head visible Dave decided to remove wet suit at this point. Very visible once wet suit removed and out of the water Head visible but low in the water

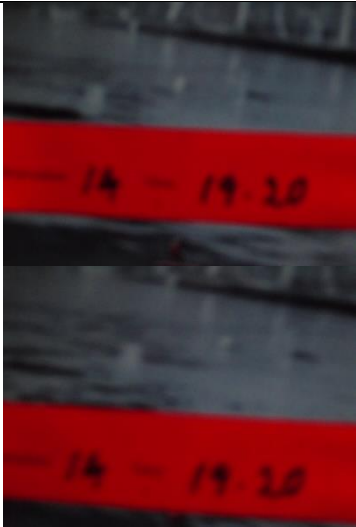
Entered water with no wetsuit/no jacket No light – no difference
14	+51	Level 50

Head visible

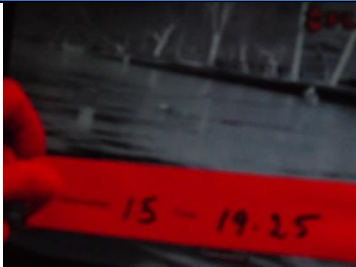
ID	Minutes	Lifejacket	Victoria Point 1		Water Police Baggly	
			Image	Comments	Image	Comments
15	+56	Full Coastal

Head visible Dave advised he was starting to experience cramp

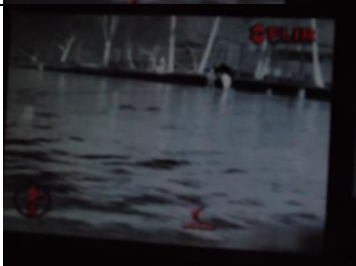
Head visible but much lower heat reading

Note the much more noticeable FLIR image once the wet suit was removed but before re-entering the water
